TRI-SERVICE CONFERENCE ON CORROSION

Electroplating and Epoxy Repair Methods for Corroded 70/30 CuNi and Alloy 400 Seawater System Components.

Mr. Timothy J. Jackovic*
Mr. Edward B. Bieberich

Carderock Division
Naval Surface Warfare Center
Code 613
3A Leggett Circle
Annapolis, MD 21402-5067

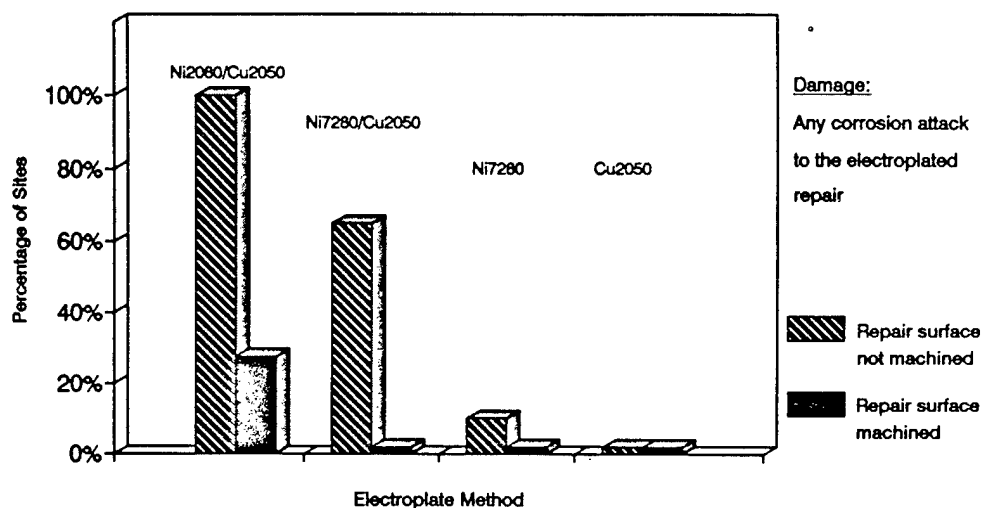
The electroplate repairs were considered to have failed when any corrosion damage occurred to the electroplate. Results of this evaluation are provided in Figure 3.

Figure 3: Results of electroplate repair corrosion tests.

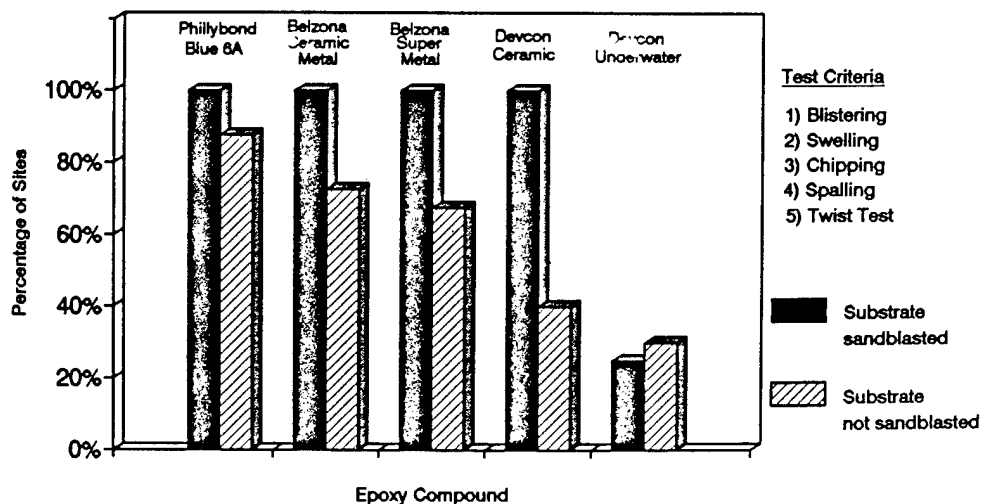
The epoxy coatings were rated as having passed or failed based on the following conditions for failure: blistering, chipping, spalling, swelling, or movement of the coating. The coatings were also considered failures if they could be twisted off by hand. The results of this inspection are provided in Figure 4.

Figure 4: Results of epoxy repair corrosion tests.

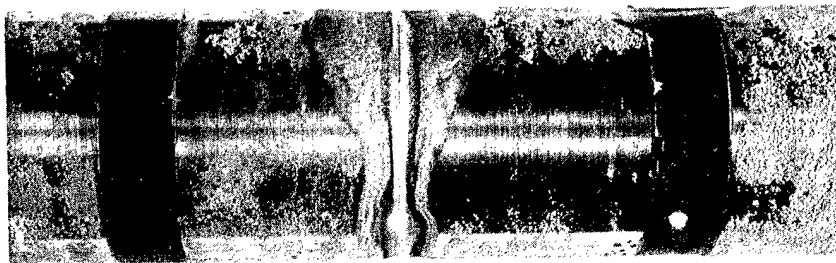
The PS specimens which had the grooves sandblasted prior to application of the epoxy showed superior resistance to failure. When sandblasted, 4 of the 5 epoxies had no failures on type I specimens. A representative specimen showing the good performance of epoxy is shown in Figure 7. Surface preparation is extremely important when applying mechanically bonded materials [2]. The roughened surface produced from sandblasting significantly increases the bond strength and therefore provides a longer lasting coating. Wherever feasible, it is recommended that sandblasting be done on all surfaces which are to be repaired by epoxy. Methods to sandblast limited access areas (eg., narrow width O-ring grooves) and to sandblast small areas on components aboard ship (without grit dust in the air) should be developed.

Figure 7. Control site (middle) and epoxy repaired sites on alloy 400 specimen repaired with Phillybond Blue 6A.

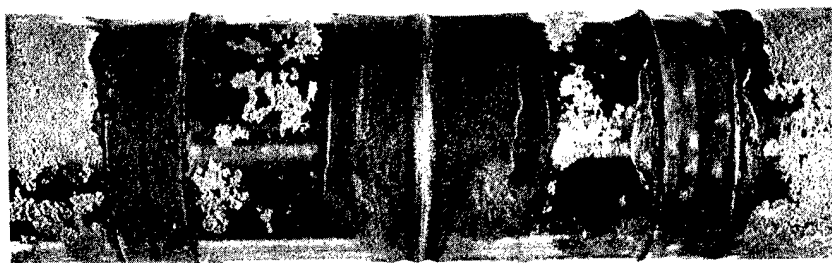
Most failures of epoxy coatings were seen on unsandblasted and type II specimens. These failures were caused by poor adhesion of the coatings allowing seawater to leak under the coatings. The Devcon Underwater had the worst performance of any of the epoxy repairs, Figure 8. Seawater leakage under this coating caused blistering and spalling of the coating. Of the 80 sites that were repaired with Devcon Underwater, 58 failed. Sandblasting of the grooved surface did not improve this coating's resistance to failure.

Figure 8. Control site (middle) and blistered epoxy repair sites on alloy 400 specimen repaired with Devcon Underwater.
